PROBLEMS OF RIVER EROSION IN MAJULI, ASSAM, INDIA: A GEO-ENVIRONMENTAL ANALYSIS

LAKHIMI GOGOI & CHINMOYEE BORPUJARI

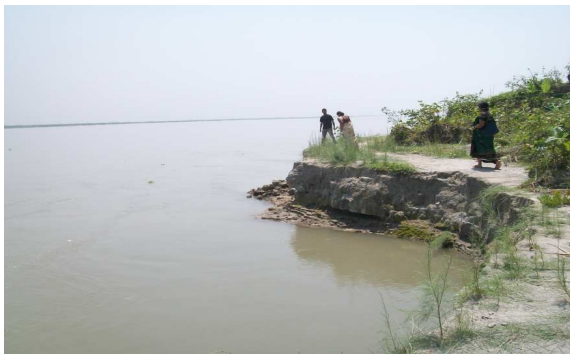
Plate 1: Erosion Sites near Afalamukh

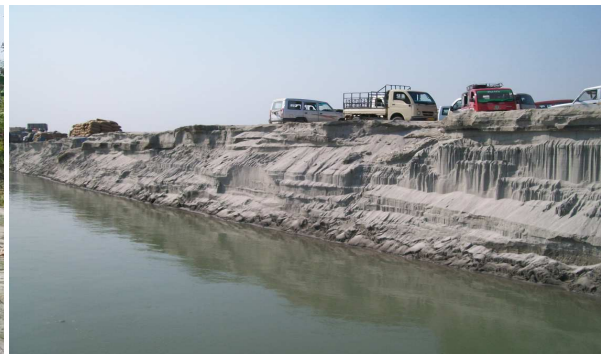
Plate 2: Extensive Erosion near Kamalabari

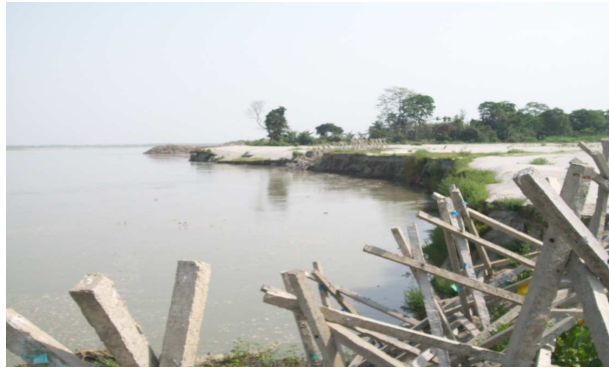
Plate 3: Protective Measures for Erosion in the Banks

To save the island, the Union Government of India has sanctioned 250 crores for the protection of the island. The water resource department & The Brahmaputra Board are struggling to solve the erosion problem of this island for the last three decade but without much success. Recently it is suggested that a four lane Highway protected by concrete mat along the southern boundary of Majuli & excavation of river bed of the Brahmaputra River, only can solve the problem . This Project, namely The Brahmaputra River Restoration Project is yet to be approved by the Government. However a nomination has been sent to the UNESCO for the declaration of Majuli to be as a world heritage site. The government has initiated the efforts to save Majuli from the ravages of the Brahmaputra. Majuli is currently in the tentative list of UNESCO World Cultural Heritage Sites and is undergoing scrutiny as a World Cultural Heritage Site. Moreover plantation of porcupines and breaches along the banks may protect the loose banks from the forceful erosive power of the river. Sandbags, large bags of concrete materials, are laid along the highly erosion prone banks of the island is a protective measure.
